Engine explosion

SOUTHWEST AIRLINES FLIGHT 1380

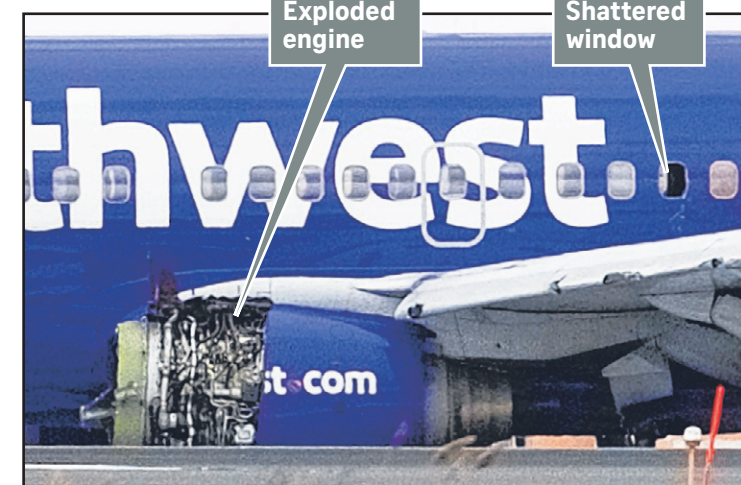
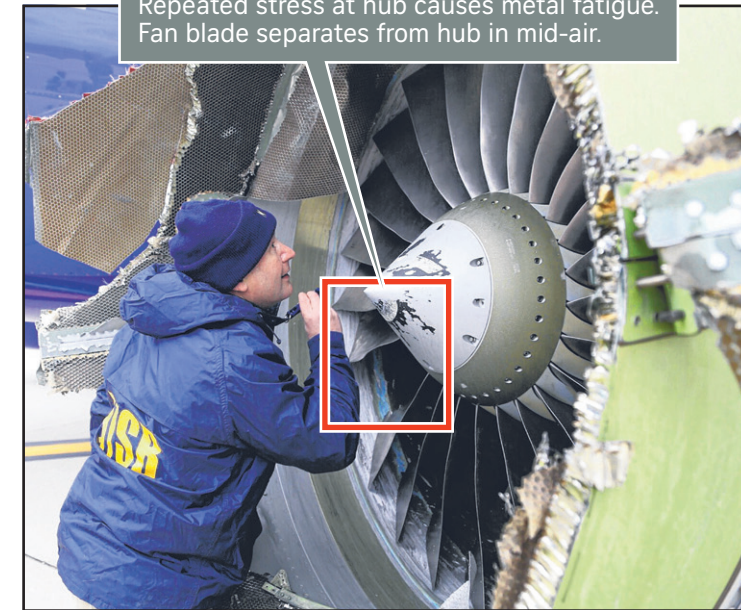
Missing fan blade

Repeated stress at hub causes metal fatigue. Fan blade separates from hub in mid-air.

The Federal Aviation Administration will issue an Airworthiness Directive (AD) within the next two weeks that will require inspections of certain CFM56-7B engines. The directive will require an ultrasonic inspection of fan blades when they reach a certain number of takeoffs and landings. Blades that fail the inspection will have to be replaced.
